Wireless Amplifier “Mobile Test”

Jack Mayer

17 August 2010

Wireless Amplifier "Mobile Test" – Large Vehicle

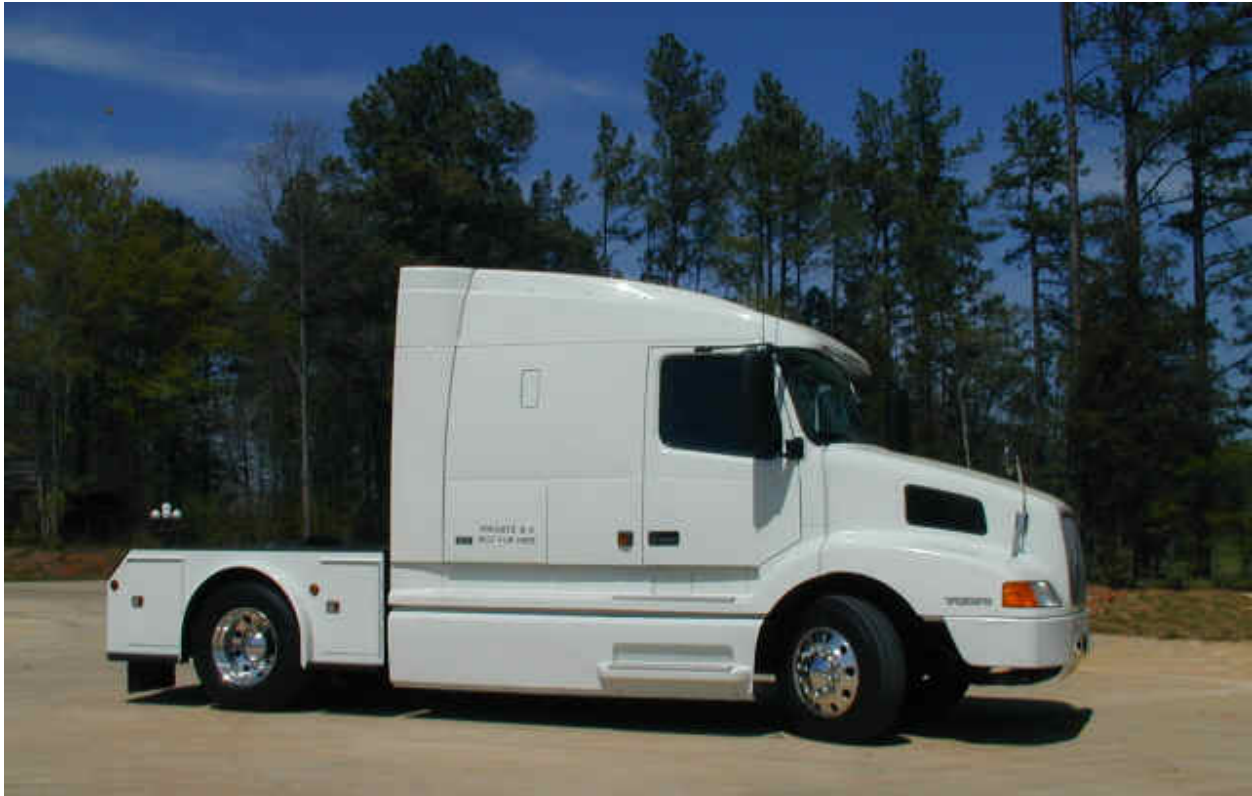
The test vehicle was a Volvo 610 semi-truck (tractor). This contains a 61" (deep) sleeper outfitted like a motor home (refrigerator, bunks, inverter, etc). It is typical of an OTR (Over the Road) tractor used to haul freight, but has been modified for RV use.

- It was difficult to mount the antennas on this vehicle. The typical mirror mount location on large trucks produced oscillation no matter where the interior patch panel was located. As a result, the Super Trucker antenna already present on this truck could not be used for a second set of tests (with a better antenna than the mag mount).

The final location of the mag mount was on a right visor strut above the windshield, with the patch on the lower left dash facing the rear. Vertical separation was 7', and horizontal separation was 7'.

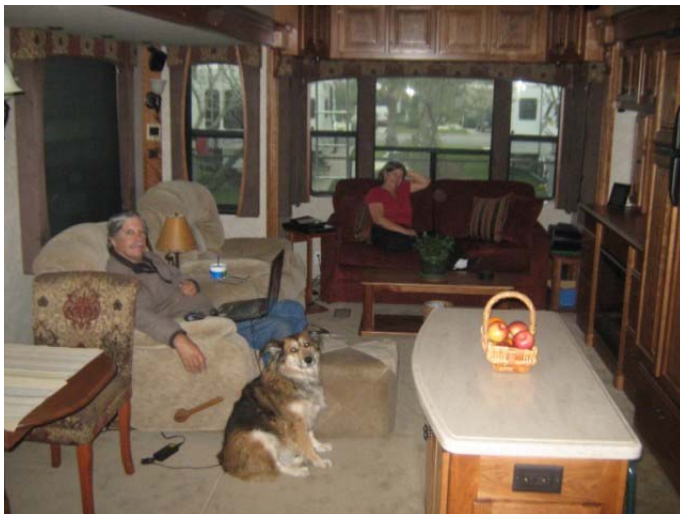
Interior test environment viewed from the patch antenna location. Data testing was performed on the island countertop.

The test was conducted in a 42' 5th wheel. The mag mount antenna was on the roof, on a 12"x12" metal plate. The internal patch antenna was inside, facing away from the omni on a

wall at 7' height. It was slightly pointed "downward" so that the main radio beam should have been focused on the living area. The vertical distance between antennas was 3.5-4', and the horizontal distance was 8'. Having the horizontal distance any closer produced oscillation after about 2 minutes. (For example, horizontal 5', vertical 5' produced oscillation)The seating area of the RV was 10-15' from the patch. The location of the data pickup (aircard) was 5' from the patch, and 3' below it.
